Evaluation of Existing Timber Structures

By Jim DeStefano, P.E., AIA, F.SEI

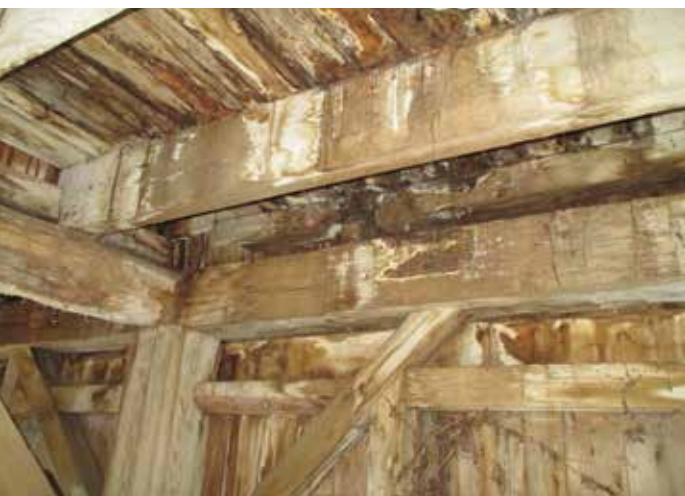
Wet discolored timber is evidence of decay.

To properly locate the damaged areas in the structure, an understanding of the places where rot is likely to occur is essential. For example, areas where persistent roof leaks are evident or where timbers are pocketed into a masonry wall are often more susceptible to rot. For a more in-depth evaluation of timber condition, an awl is a simple and indispensable tool for probing the surface of a timber to identify the depth and extent of deterioration, from either

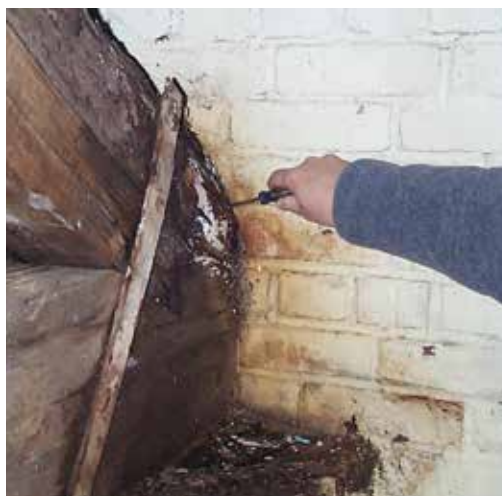
An awl is an effective tool for evaluating surface deterioration.

rot or insect damage. Any portion of the wood that can be penetrated with modest pressure from an awl should be assumed to be impaired.

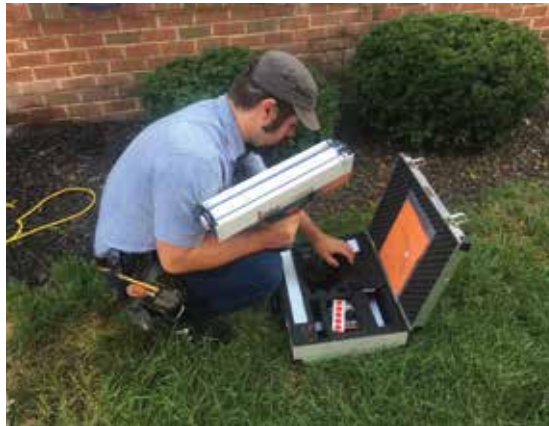
A resistance drill can identify hidden deterioration within a timber.

Some form of nondestructive evaluation (NDE) may be warranted if hidden deterioration is suspected. There are some sophisticated NDE systems such as ultrasonic stress-wave measurements that have been used with limited success in evaluating deteriorated timbers. Although not entirely non-destructive, resistance drilling is an effective method that leaves minimal evidence of the test.

Resistance drilling creates a small diameter hole (typically $\frac{1}{8}$ inch) in the timber, and the torque required to advance the drill bit is measured and plotted versus depth. Rotted or insect-damaged areas clearly show up.

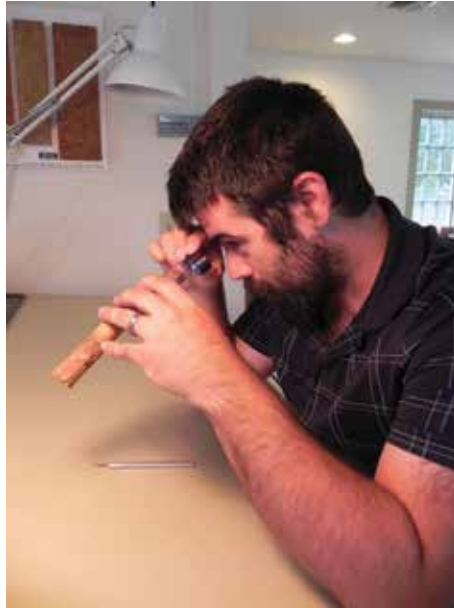
Examining the end grain of a timber specimen with a hand lens to identify the wood species.

The timber species must be identified before design values can be determined. Some timber species, particularly hardwood species, have distinctive characteristics that can be visually identified by a trained eye. However, since timbers in existing structures are often aged, stained, dirty, or even painted, it is usually necessary to take specimens of the timbers and examine the anatomical features of the wood with a hand lens or under a microscope to determine the wood species.
