# STAMFORD MEDIA VILLAGE

## A RHINESTONE IN THE ROUGH

By Joe Gencarelli, P.E., and Jim DeStefano, P.E., AIA, F.SEI

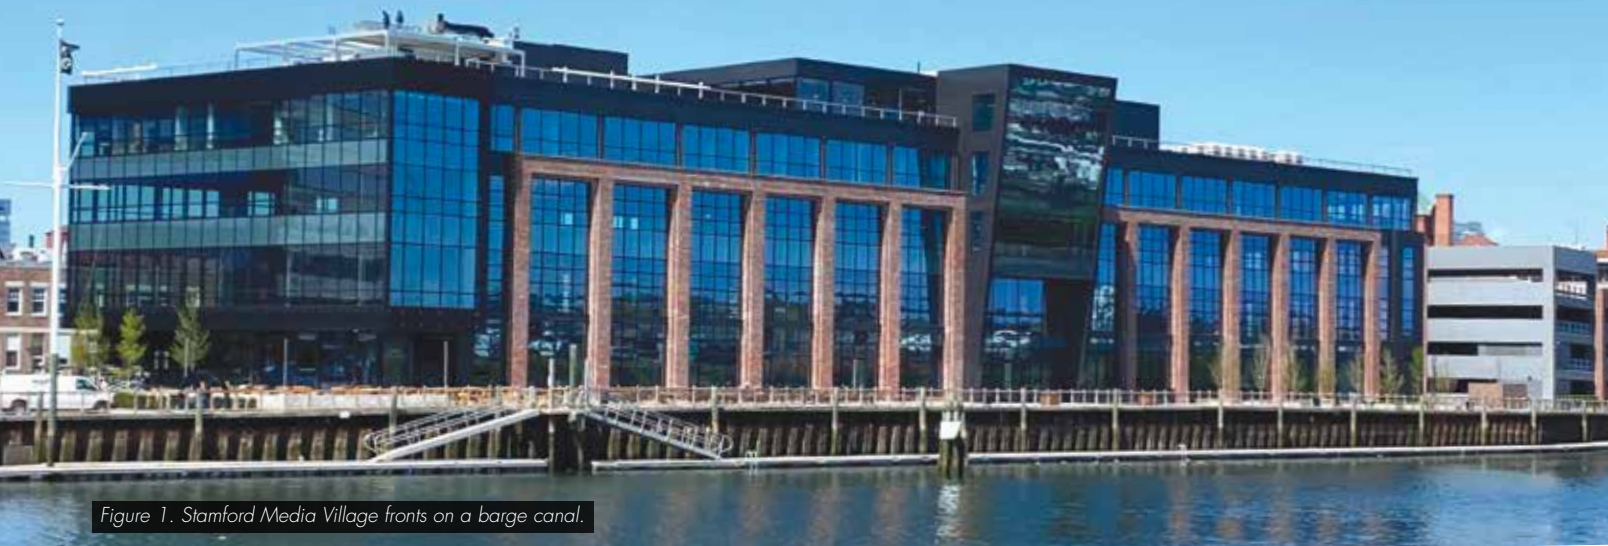
Figure 1. Stamford Media Village fronts on a barge canal.

Stamford Media Village is not just another nondescript five-story office building (Figure 1). What is so unique about this project? Everything! Rewind to 2018 when Wheelhouse Properties acquired a derelict 1920s vintage reinforced concrete factory building located at the South end of Stamford, Connecticut – a

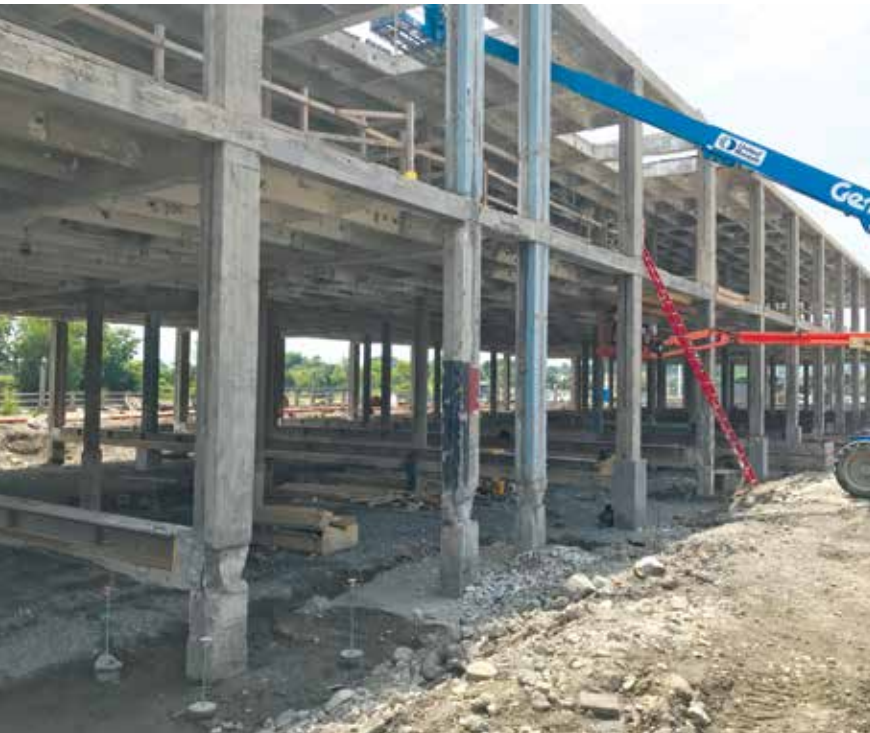
Figure 2. The crumbling concrete carcass before the transformation.

DeStefano & Chamberlain, Inc. was engaged as the structural engineer for the project. After a detailed condition assessment of the existing derelict building, the recommendation was “knock it down!” That was not an option that Wheelhouse Properties would consider. Instead, they were determined to save the structure. Their vision was to add three stories on top of this two-story crumbling carcass of a building and transform it into something spectacular (Figure 2). To do so would require innovative structural solutions.

The derelict concrete structure, which is a one-way concrete joist framing system, was in rough shape. It was reinforced with twisted square bars called "Ransome Bars" after their inventor, Ernest Ransome.

Due to the proximity to the canal, the crawl space below the building was frequently inundated with tidal water. As a result, most of the ground floor concrete structure was severely spalled and deteriorated from immersion in seawater.

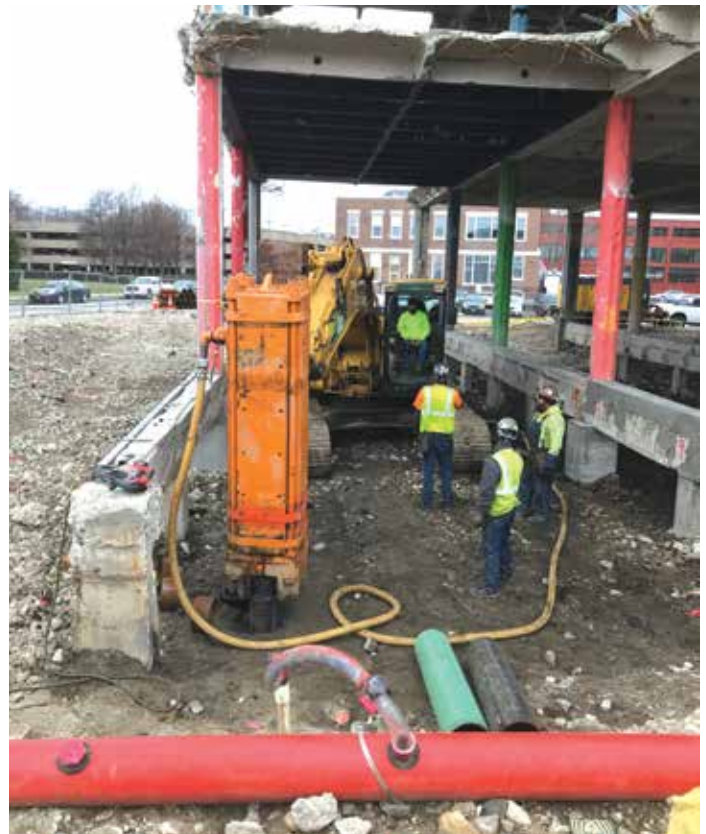
Figure 3. Custom pile driving rig.

Given the limited vertical clearance, trying to install deep foundations within the building would take some ingenuity. Drilled micro-piles extending to bedrock were first considered; however, the contaminated drill spoils would have required costly remediation and disposal. The underpinning solution settled on concrete-filled steel pipe piles driven to bedrock. The piles were spliced every five feet with compression couplings that eliminated the need for field welding. The foundation contractor, Norwalk Marine Contractors, fabricated a custom rig with a pile hammer secured to the arm of an excavator that could operate inside the existing structure with restricted headroom (Figure 3).

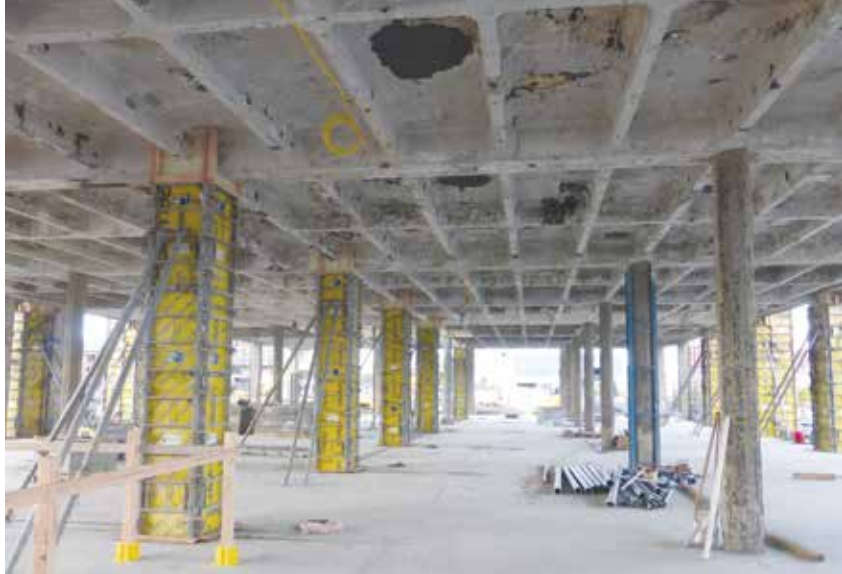
Figure 4. Concrete columns were reinforced and jacketed to increase capacity.

The concrete restoration specialists from Structural Technologies were brought in to perform the column fortification. These columns, which are octagonal in shape, were jacketed with 3 inches of concrete and reinforced with vertical corner bars and ties. The concrete floor was cored in the corners of each column being fortified to install continuous vertical column bars. Self-consolidating concrete (SCC) was pumped into the column jackets through the core holes (Figure 4).

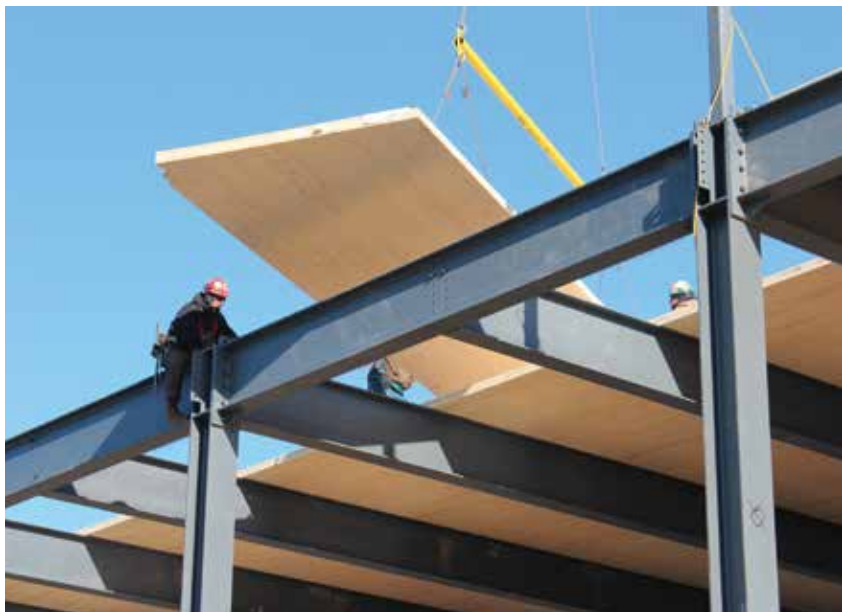
Figure 5. Cross-laminated Timber (CLT) panels being erected over a structural steel frame.

A hybrid of Architecturally Exposed Structural Steel (AESS) and Cross-Laminated Timber (CLT) panels was proposed. At the time that the hybrid solution was conceived in 2018, no hybrid structure of this kind had been built (Figure 5). Upon completion, Stamford Media Village became the second hybrid Mass Timber/Structural Steel building in New England.

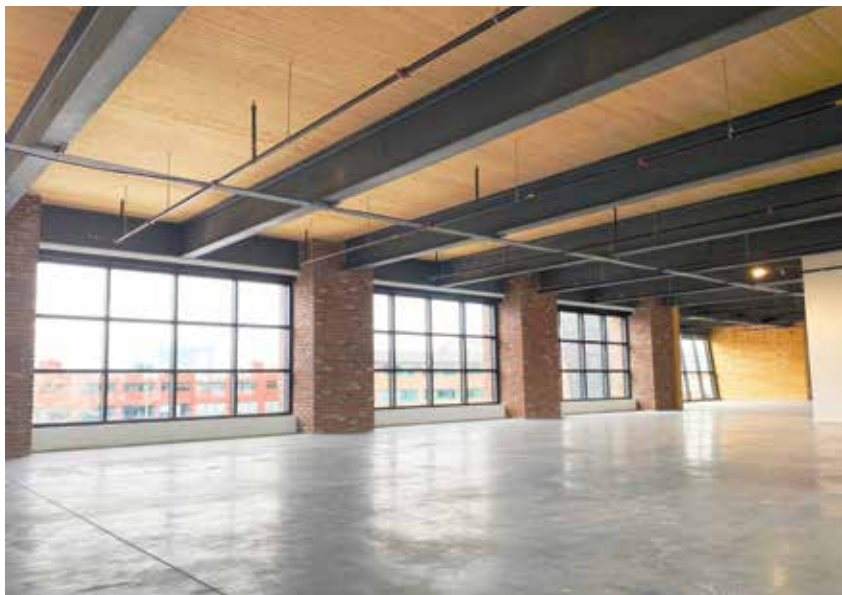
Figure 6. Architecturally exposed hybrid structure awaiting a tenant.

Using a hybrid system resulted in significant advantages. It resulted in a lighter structure which in the end saved foundation underpinning costs. The combination of AESS and CLT panels resulted in a cool-looking, unique structure (Figure 6).
