Keyed Through-Tenon Performance

Editor's note. This article was adapted from the Guild's Timber Frame Engineering Council's "Technical Bulletin 2016.8," a brief summary of extensive research done outside the Guild to quantify the strength of keyed through-tenon joints in timber. The bulletin was published in July and prepared by Daniel Hindman, Associate Professor in the Department of Sustainable Biomaterials at Virginia Tech, and Jim DeStefano, president of DeStefano & Chamberlain, Inc., and TFEC publications committee head for 2016. The original research on keyed through-tenon joints was conducted by Lance David Shields under the supervision of Professor Hindman and presented in June 2011 as an MS thesis in Civil Engineering under the title "Investigation of Through-Tenon Keys on the Tensile Strength of Mortise and Tenon Joints."

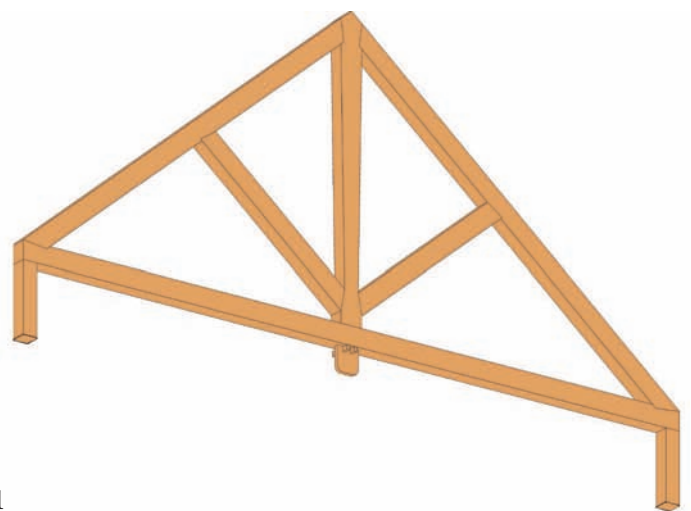
1 Representative kingpost truss with through mortise in tie beam and extended post tenon with two keys.

KEYED through-tenon joints use an extended tenon secured by one or more wedges passing across it on the far side of a through-mortise. Such joints, also known as outside-wedged through-tenons, are sometimes found in kingpost trusses to join the kingpost to the bottom chord (Fig. 1). They are commonly found in New World Dutch barns joining the anchor beam to the posts in the characteristic H-bent (Fig. 2). Little engineering design literature exists for these joints.

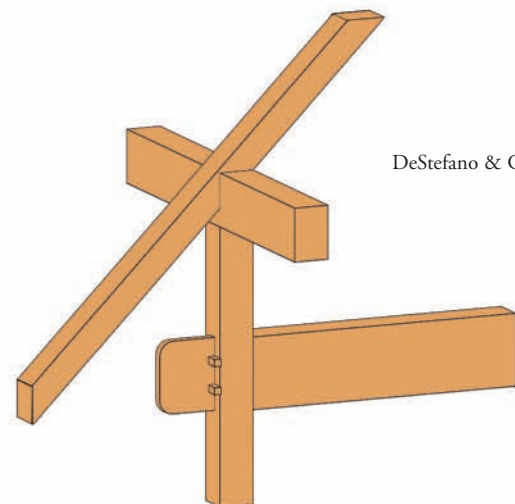
2 Representative New World Dutch barn anchor beam connection to purlin post with extended tenon and two keys.

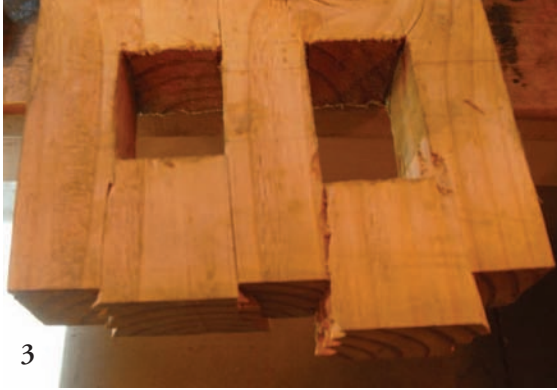
3 Relish failure in shear along the grain in Douglas fir tenon with two keys and short relish.

Joints with relatively short tenons (4-in. projection) tended to fail when the relish behind the key mortises sheared off. Joints with long tenons (11-in. projection) did not exhibit this failure mode. Relish shear failures are a brittle failure mode to be avoided, thus it is crucial that tenons be long enough to preclude it.

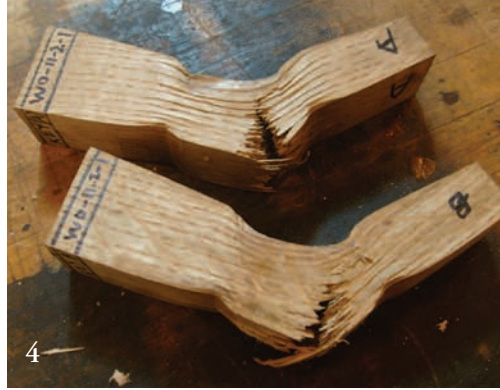
4 Bending and crushing of white oak keys in long-relish white oak.

Keyed through-tenon joints that did not experience brittle relish shear or splitting failures behaved in a ductile fashion. The keys first crushed at their bearing surfaces and then progressed to a bending failure. Even after the keys fractured in bending, the joint continued to resist load, exhibiting ductile behavior. All of the joints tested used a single wedge as a key. Pairs of opposing wedges instead of a single wedge may be anticipated to result in improved bending resistance.

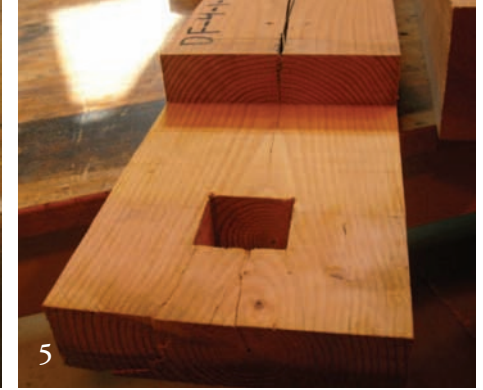
5 Tenon split in short-relish Douglas fir tenon with single key.

A second brittle failure mode observed was splitting of the tenon, caused by tensile stress perpendicular to the grain of the tenon. This failure mode was only observed in joints that contained a single key. Joints with two keys did not exhibit splitting failures.

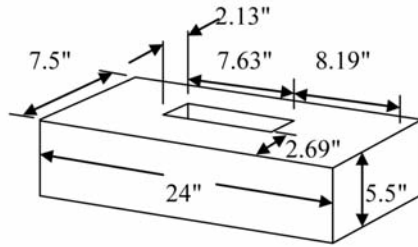
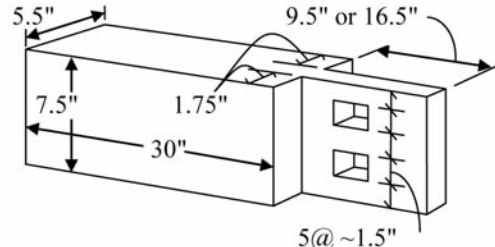
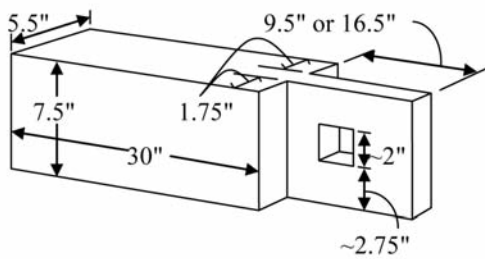
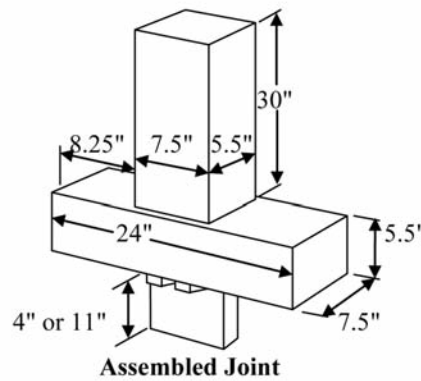
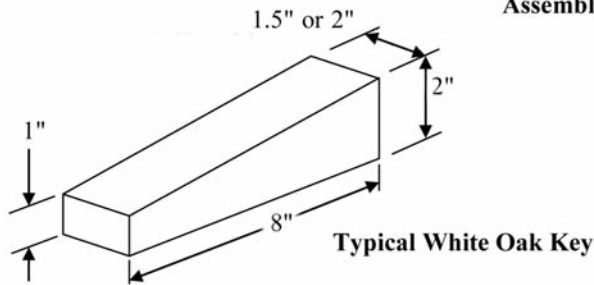
Mortise Member

Tenon Member for Two Keys

Tenon Member for One Key

Assembled Joint

Typical White Oak Key

6 Configuration and dimensions of test joints. Not to scale.

Test specimens were fabricated from Douglas fir and white oak and tested to failure to identify potential failure modes (Figs. 3–7). Specimens with different tenon lengths (4 in. and 11 in.) were tested, as well as specimens with one key and two keys.

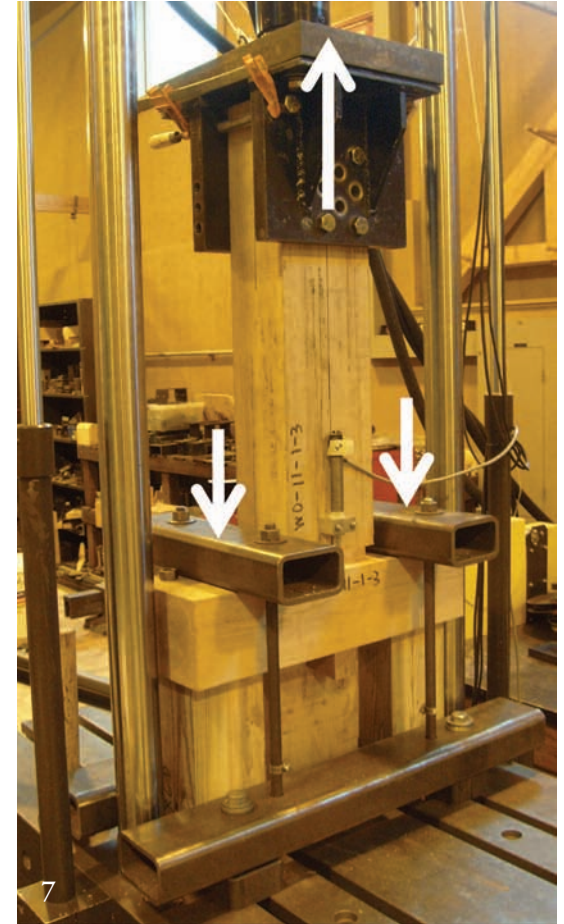
7 MTS Servo-Hydraulic test apparatus with load cell range of 50,000 lbs. Lower white arrows indicate clamps holding mortised piece on blocks. Transducers with range of 2 in. and sensitivity of 0.001 in. are attached at opposite sides of joint to measure tenoned member slip relative to mortised member.

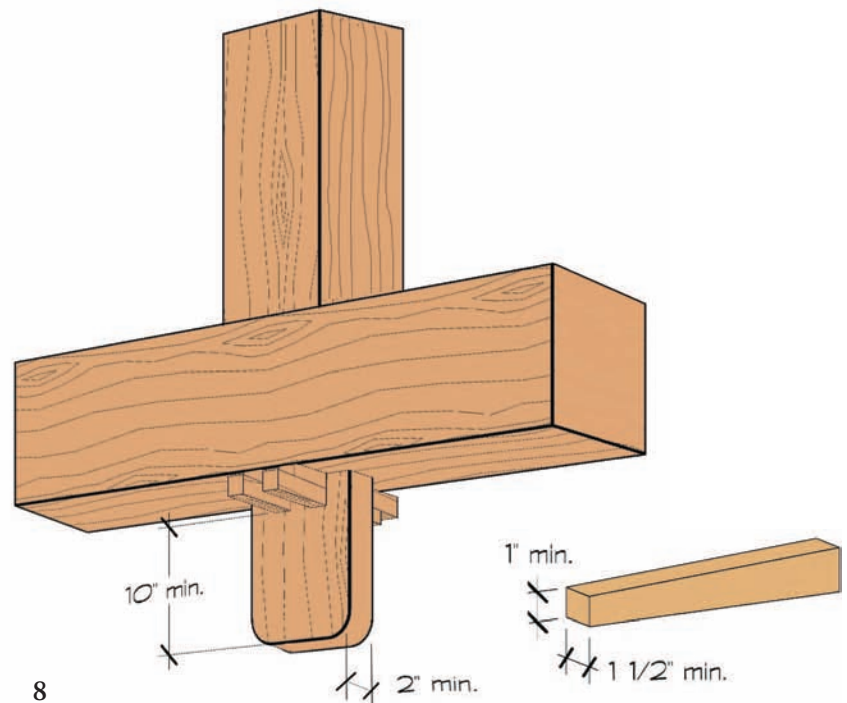
8 Keyed through-tenon recommended mortise end distance and dimensions. Hypothetical folding wedges not tested.

THE following guidelines for proportioning and maintaining keyed through-tenon joints are intended to minimize the likelihood of a brittle joint failure. Minimum dimensions are indicated and may need to be increased where required by structural calculations (Fig. 8).

1. The distance from the key mortise to the end of the tenon should not be less than 10 in.
2. A minimum of two keys should be used, each ideally consisting of opposing wedges.

3. Tenon thickness should be not less than 2 in.
4. Key mortises should be sized to allow for seasoning (shrinkage) of the tenon and consequent tightening around the keys.
5. Keys should be made from seasoned hardwood with a specific gravity not less than that of the timber.
6. As the mortised timber seasons and shrinks, keys must be tightened to keep the face of the joint closed.
