TFEC 3-2018

Guide to Structural Evaluation of Existing Timber Structures

December 2018

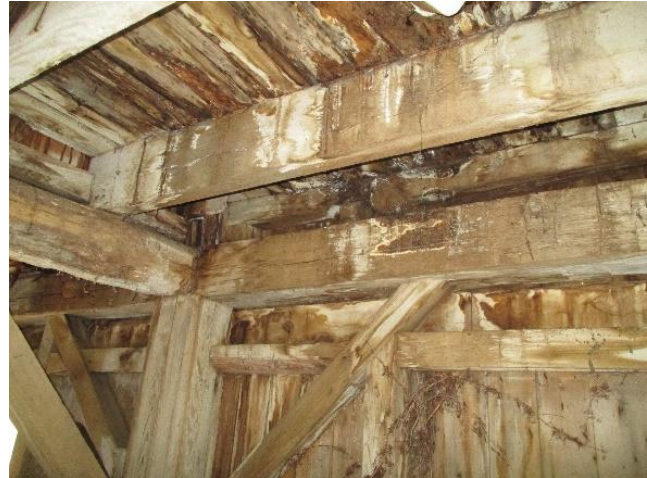
Figure 3 Discoloration can be a sign of rot

As decay progresses and the rot fungi digest the wood fiber, the infected timber will lose mass and strength. Early stages of decay characterized by wood discoloration and the surface being soft and punky is referred to as incipient decay. A 10% mass loss associated with incipient decay can result in an 80% reduction in structural load resistance. Advanced decay results in a near total loss of strength.

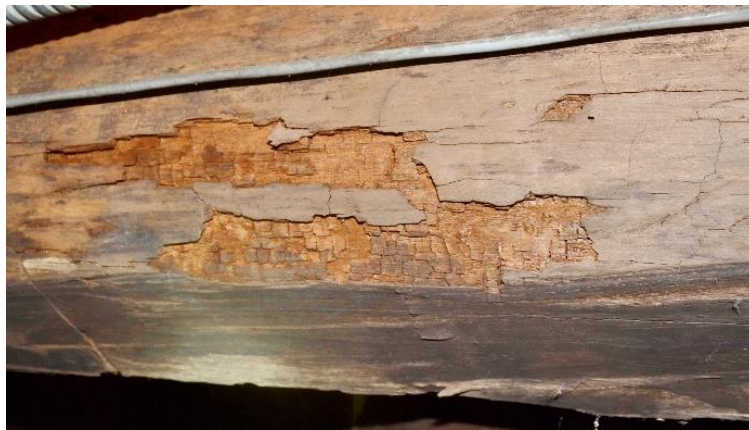
Figure 4 Brown rot

Fungal Decay: Fungal decay – often simply called decay or rot is by far the most common type of timber deterioration. Rot is caused by a fungus that feeds on the lignan and cellulos fiber of the wood. There are a variety of rot fungi types. Dry rot, also referred to as brown rot, is the most common form of decay, while wet rot and white rot are not uncommon. Precise identification of fungi is difficult and not necessary for most projects. All rot fungi require water, warmth, oxygen, and a wood food source to grow and thrive. Consequently, only wet timber will rot. Timbers fully submerged in water will not rot due to the absence of oxygen, while partially submerged timbers will frequently rot just above the water line.

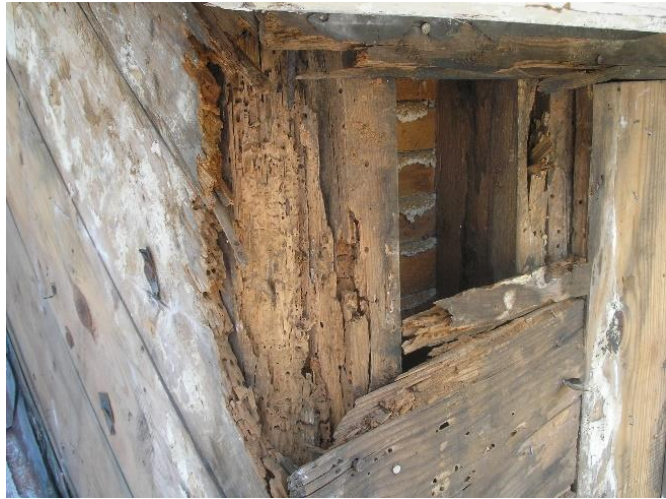
Figure 5 Termite damaged timber

Subterranean termite damage progresses at a very slow rate and the damage tends to be confined to the lower portions of the structure that are close to the ground. It often takes decades for an active termite infestation to do substantial damage. That is not true for termite varieties that are indigenous to tropical climate zones. Drywood termites and Formosan termites are found in the southern United States. These species of termites can do significant damage in a relatively short period of time.

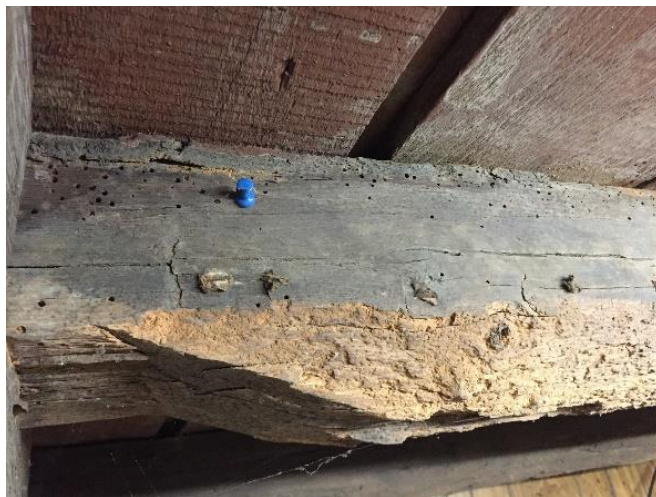
Figure 6 Powder post beetle damage

Powder post beetle larvae will burrow into a timber from the surface and digest wood fiber as they tunnel through it. When the beetles reach adulthood, they emerge from the timber and lay their eggs on the surface for the cycle to begin again. In contrast to termite damaged timber, timber infected with powder post beetles will be peppered with pin size emergent holes on the surface that ooze a fine powdery frass that is the consistency of flour. The sapwood of the timber will often be soft and punky while the heartwood may be sound.

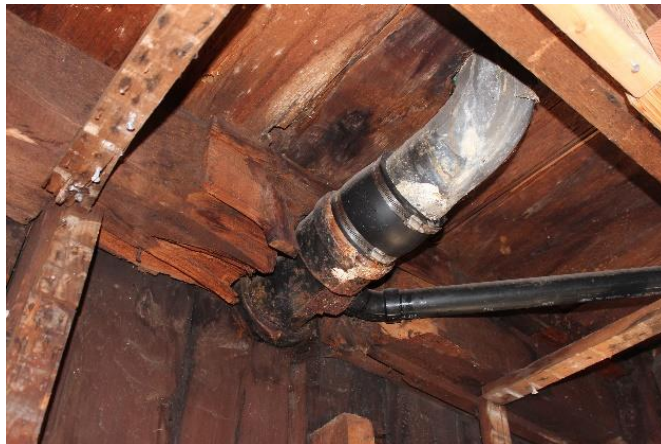
Figure 7 A timber that has been compromised

When evaluating the structural impairment associated with insect damage, the damaged wood is treated as a void in the timber.

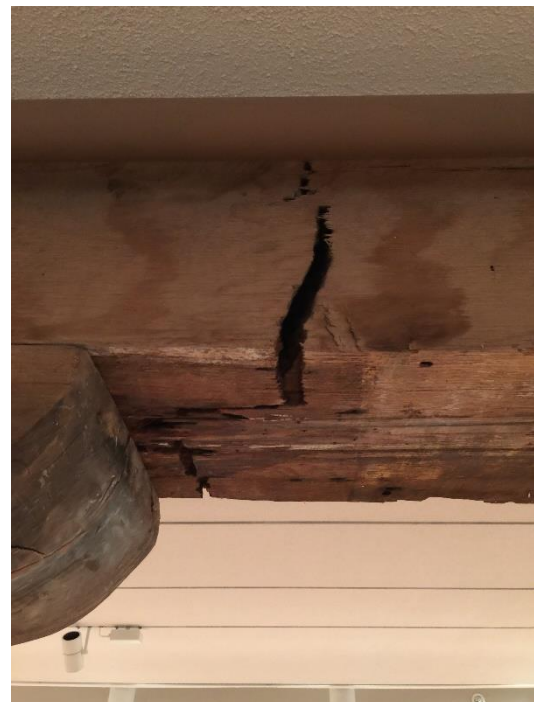
Figure 8 Fractured timber due to overloading

Fractures are a rupture of the wood fibers across the grain and are distinctively different from a seasoning check which is parallel to the grain and not caused by structural overloading.

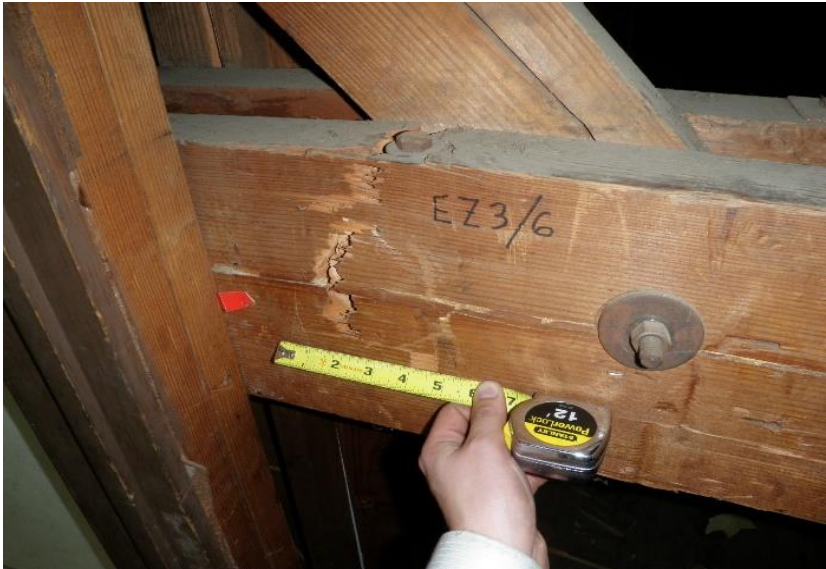
Figure 9 Tension fracture in bottom chord of a bowstring truss

Truss bottom chords designed according to early versions of the *National Design Specification for Wood Construction (NDS)* are prone to tensile failure due to unconservative published allowable stress limits contained therein. Bowstring trusses built during and after World War II are particularly vulnerable to failure.

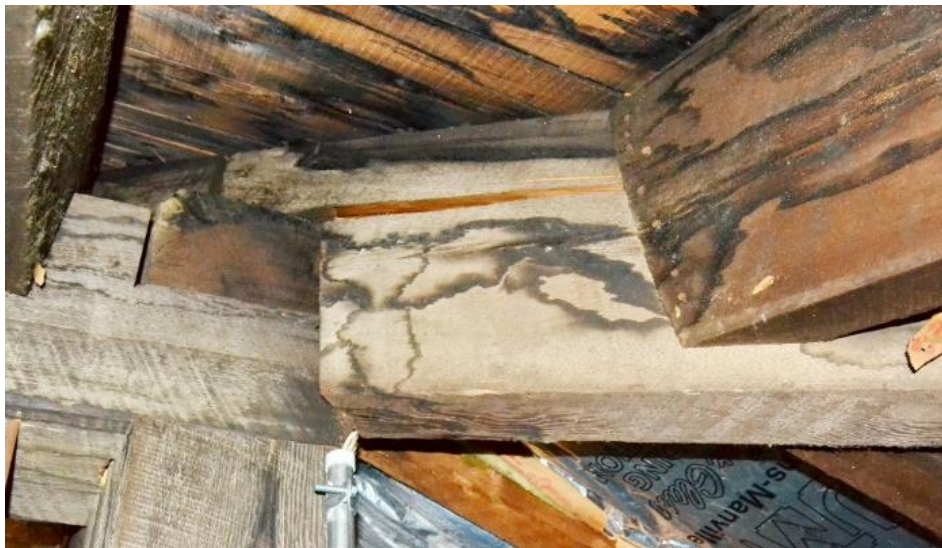
Figure 10 Split in a notched timber

Splits along the grain caused by notching of members subjected to high shear stress can be a cause for concern. Unlike a seasoning check, a split extends through the full thickness of a timber.

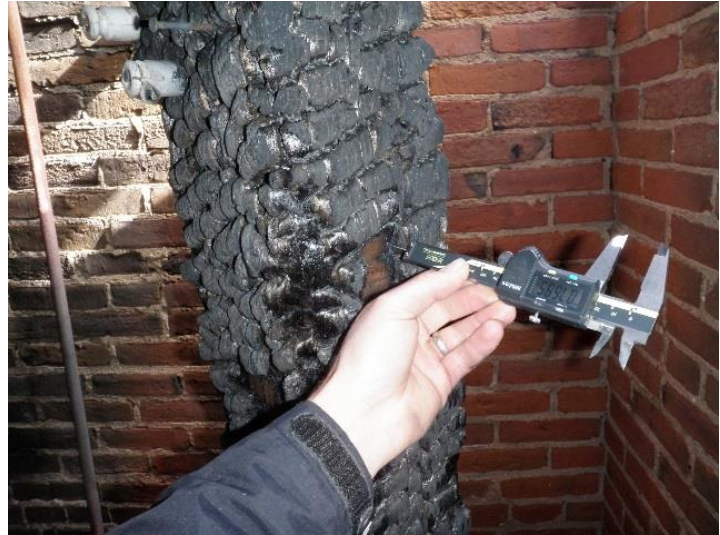
Figure 11 Fire damaged timber

In evaluating the residual strength of a fire damaged timber, the char layer can be assumed to have no structural load resistance. The heated zone directly behind the char layer can be assumed to have diminished structural properties. The heated zone is typically about $\frac{1}{4}$ inch thick. The remaining timber behind the heated zone can usually be assumed to have the same structural properties as if there had been no fire.

It is necessary to accurately measure the depth of the char layer and estimate the dimensions of the remaining sound timber below the char layer and heated zone to analyze the residual load carrying capacity.

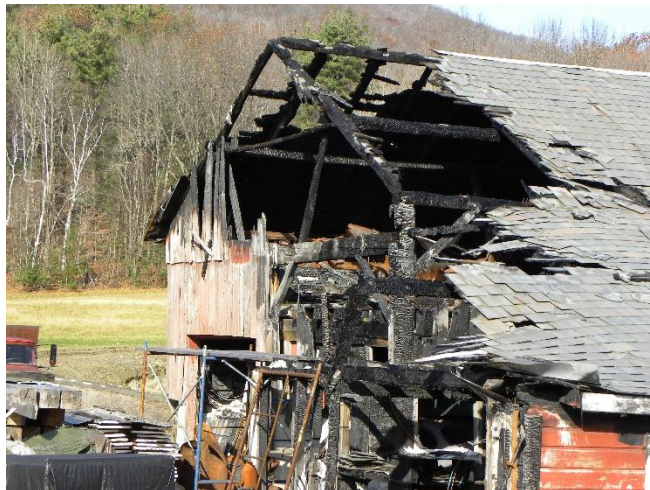
Figure 12 Fire damaged barn

Particular attention needs to be paid to evaluating the fire damage to the connections. Steel bolts and connection hardware should be carefully examined. Since steel readily conducts heat, the wood in contact with steel connectors is often severely charred. Concealed steel connection hardware is typically protected from fire damage by the surrounding wood unless the wood cover is less than the depth of the char layer.

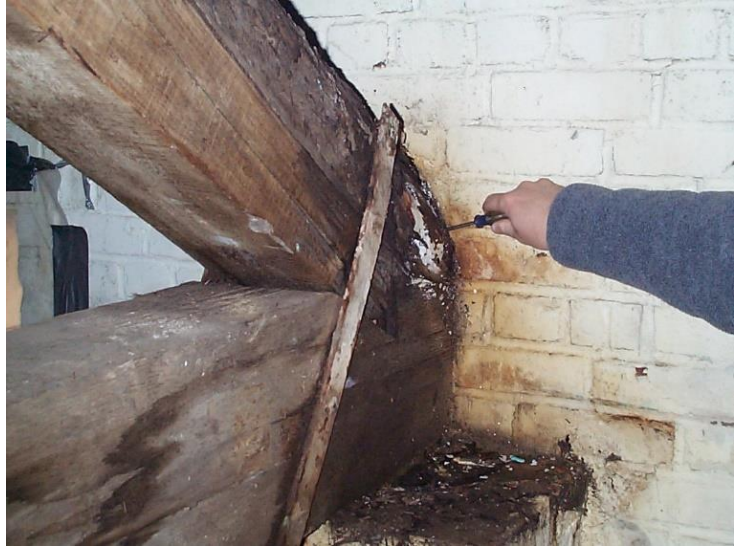
Figure 13 An awl is used to probe for rot.

Areas where persistent roof leaks are evident or where timbers are pocketed into a masonry wall are the most susceptible to rot. An awl is a simple and indispensable tool for probing the surface of a timber to identify the depth and extent of deterioration. An awl is also useful in identify the extent of insect damage. Any portion of the wood that can be penetrated with modest pressure on an awl should be assumed to have negligible strength.

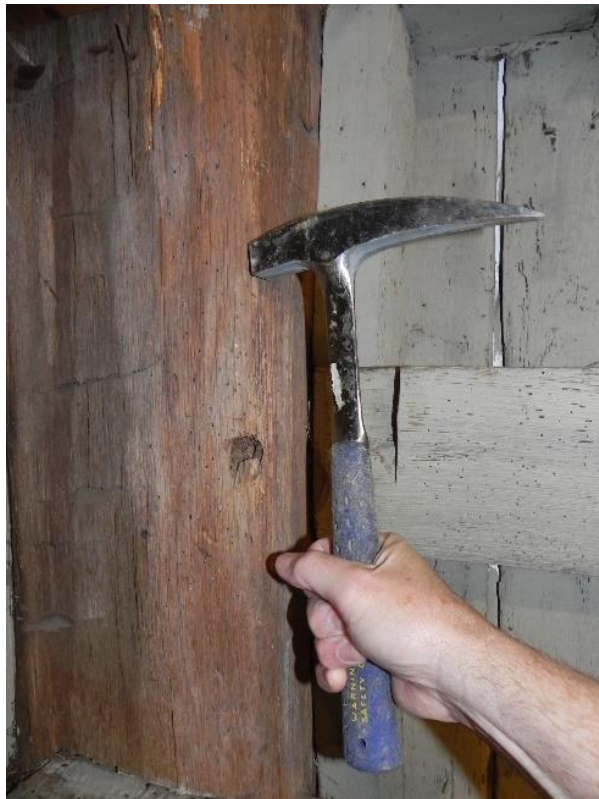
Figure 14 A rock pick can be used for sounding

There may be deterioration present within the core of a timber that cannot be seen and is too deep to probe with an awl. Sounding with a hammer can be effective at identifying areas where hidden deterioration exists. The sound that the timber makes when struck with the hammer is an indication of the soundness of the timber. A dull thud indicates that there may be internal deterioration which tends to dampen high frequency sound waves traveling through a timber. The hammer sounding technique is highly subjective but may signal to the investigator the presence of voids or hidden deterioration.

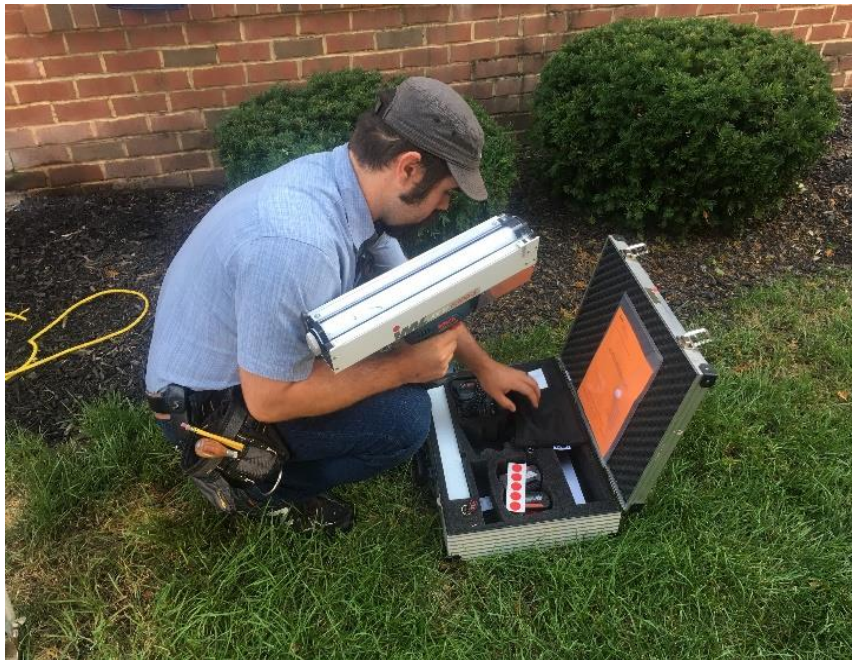
Figure 15 A resistance drill is a useful tool for identifying deterioration hidden below the surface

Resistance drilling creates a small diameter hole (typically 1/8") in the timber and the torque required to advance the drill bit is measured and plotted versus depth. Rotted or insect damaged areas clearly show up although regions of incipient decay are often difficult to detect in softwood species.

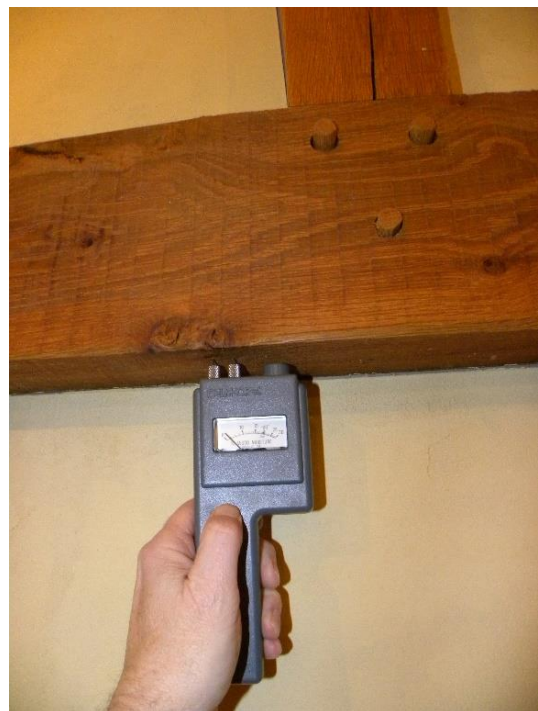
Figure 16 Hand held moisture meter

It is worthwhile to measure the moisture content of the timbers. A high moisture content (above 30%) is an indicator that conditions are conducive to rot deterioration.

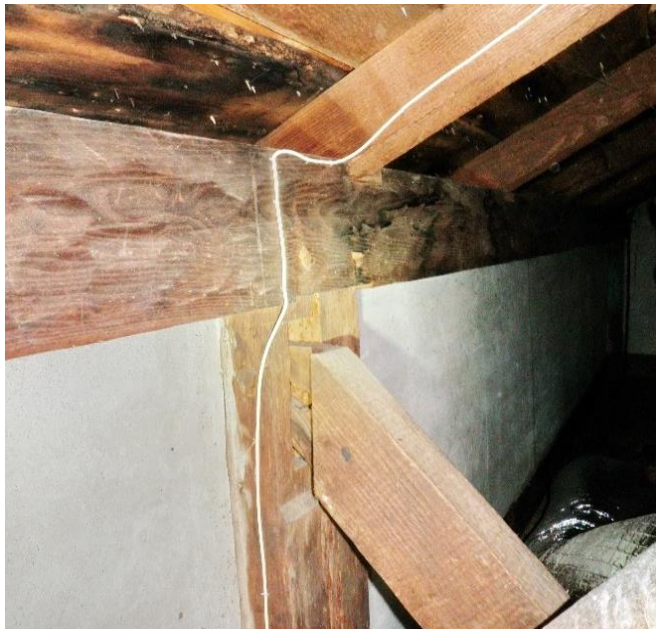
Figure 17 Shear failure in the tenon (relish failure) of a rising brace

Signs of structural distress such as fractured or deflected timbers should be identified and documented. Particular attention should be paid to connections and joinery since that is where most structural failures initiate.

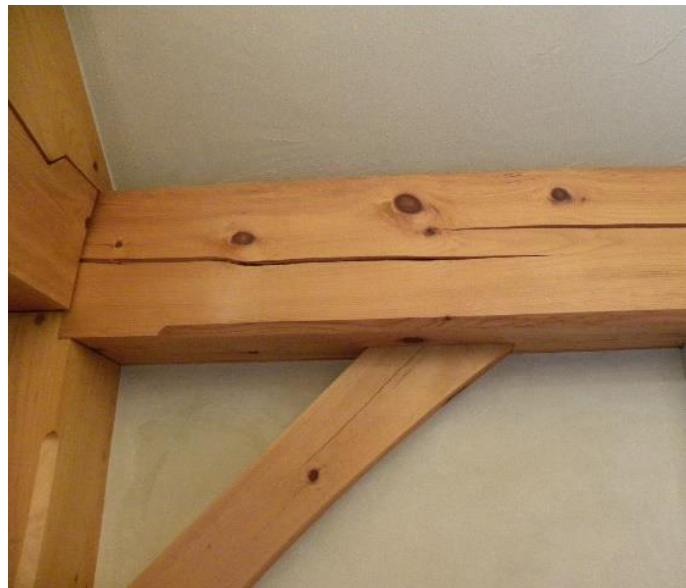
Figure 18 Seasoning checks are not material defects

Seasoning checks are often misidentified as structural defects. Checks are ordinary timber features and are not defects. No reduction in design bending strength is warranted for a checked timber beyond the reductions already incorporated into the Building Code. Checks typically do not require remediation unless the checks affect the performance of connections. Misguided remediation of seasoning checks, such as applying bolted steel straps across the check, can lead to splitting of a timber during subsequent moisture cycles. Filling checks with epoxy is also ill-advised since it can lead to moisture entrapment and subsequent decay.

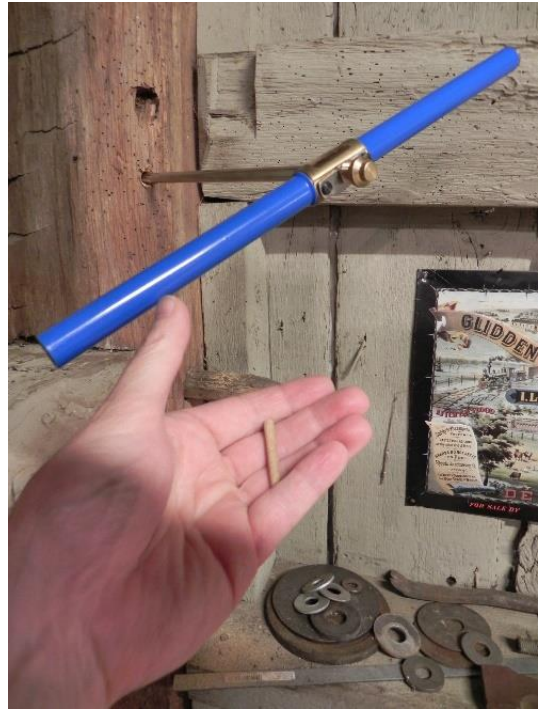
Figure 20 A specimen extracted from a timber with an increment borer

A piece of solid wood measuring approximately 3/8 to 1/2 inch square by 3 inches long parallel to grain is sufficient to permit examination of end grain features with a hand lens or to obtain thin sections for study under a compound microscope. Avoid areas with rot, char or physical damage as the anatomical features may be too damaged to permit species identification.

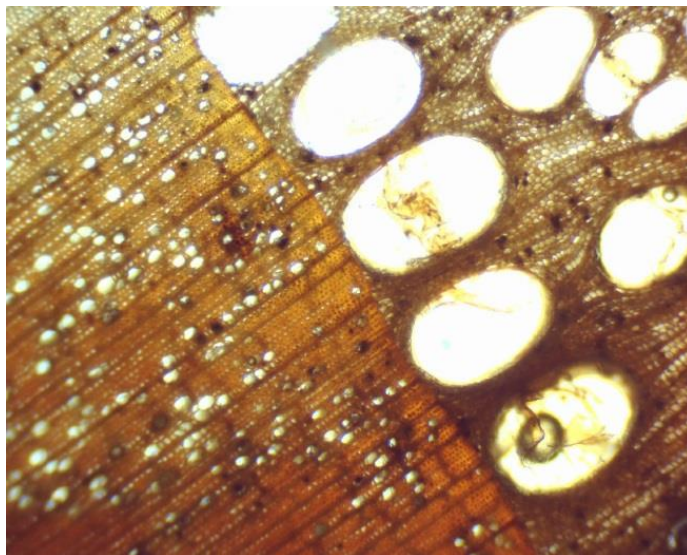
Figure 21 40X magnification of the end grain of American Chestnut *Castanea Dentata*

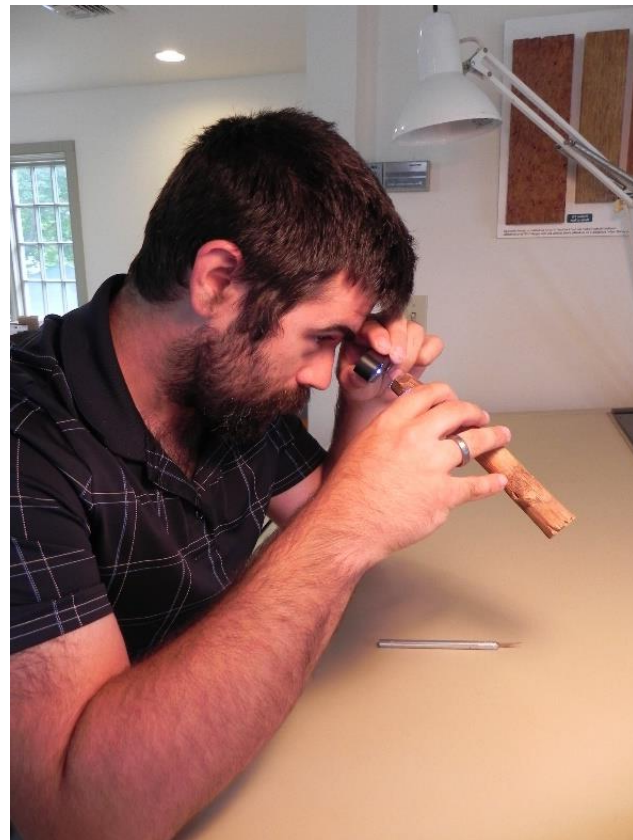
Figure 22 A hand lens is used to examine the anatomical features of a wood specimen

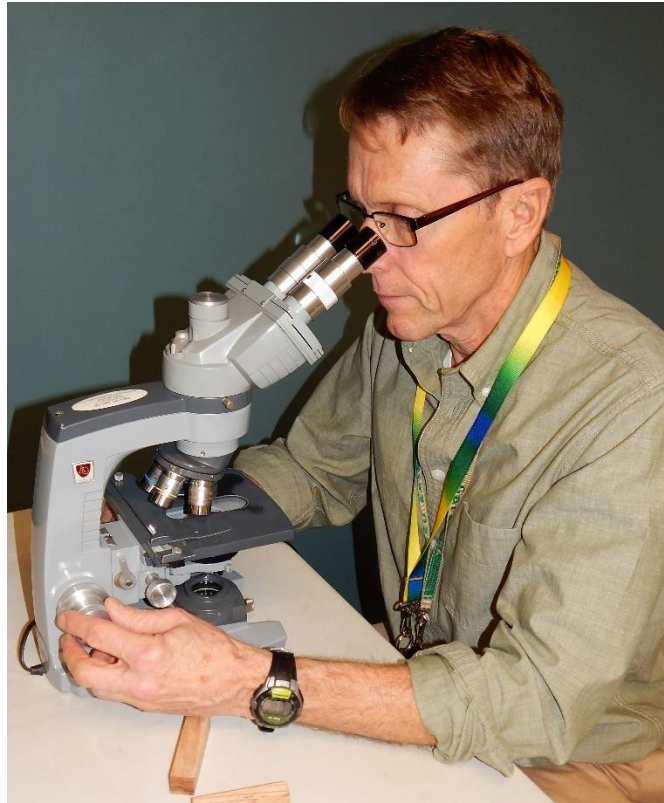
Figure 23 A microscope is used for precise species identification

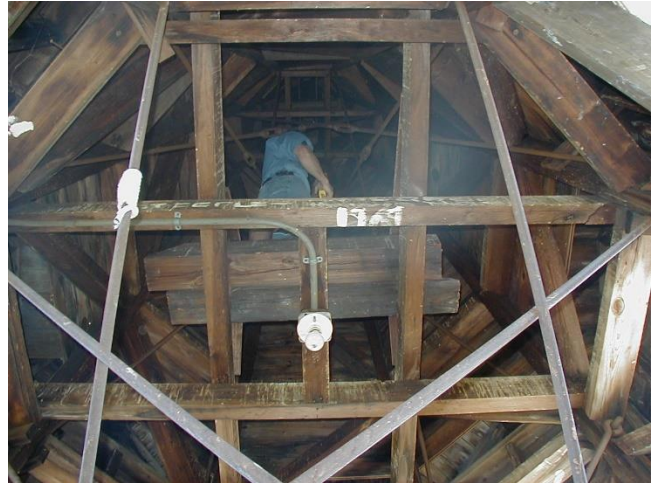
Figure 24 Evaluation and grading of timbers in a church steeple

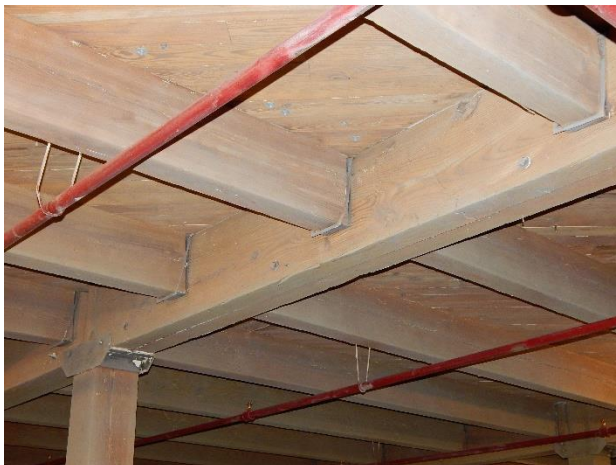
Figure 25 Blast cleaning of timbers makes grading more reliable

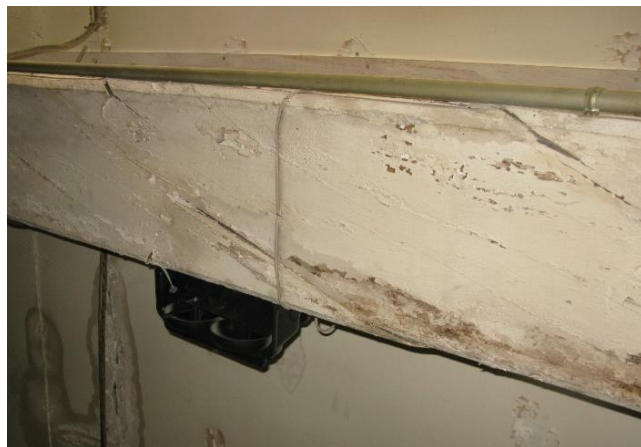
Figure 26 Spiral grain

Slope of grain in a timber can result from either spiral grain or from sawing straight sticks from crooked logs or from the base of strongly flared stems. No strength ratio is given in ASTM D245 for shear parallel due to slope of grain. This might be interpreted to mean that slope of grain need not be considered when determining design values for shear and that in regions of little or no bending the slope of grain could exceed 1:6. This topic requires more study; refer to the section below on Interpretation of Findings. Spiral grain likely does not produce any reduction in shear parallel to grain strength since fibers on opposite faces of a timber slope in different directions and create an interlocking pattern relative to

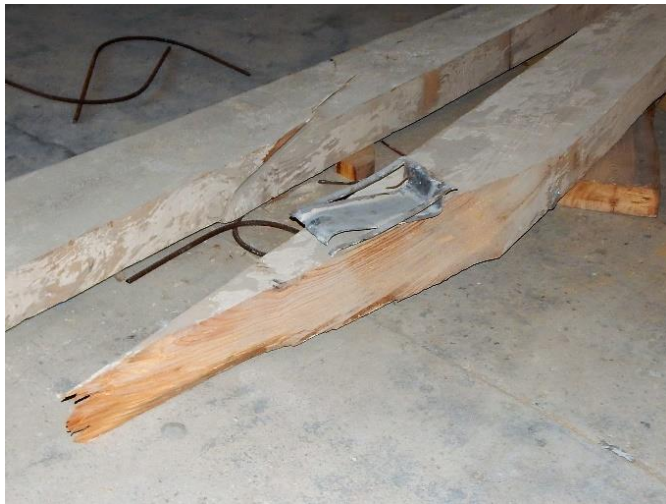
Figure 27 Failure due to excessive slope of grain

shear parallel to grain. When the orientation of the grain slope generates tension perpendicular to grain, such as develops when the slope is angling down towards the support at the ends of simple span members, it is prudent to limit slope of grain to a maximum of 1:6 in locations of high shear stress, that is shear stress approaching the maximum allowable design stress. This value for slope is within the bounds for No. 2 grade and so is consistent with current practice and experience.

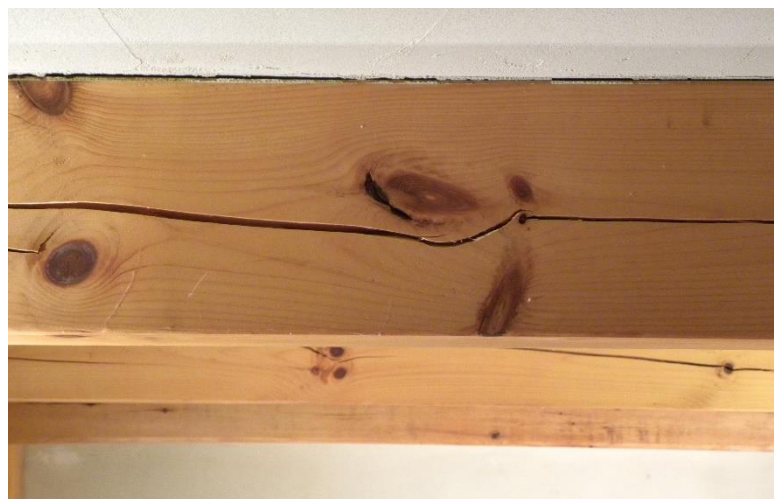
Figure 28 Grain deviation at knots

Knots: The actual strength-reducing effect of knots is due to the deviation of grain around the knot that results in tension perpendicular to grain and shear parallel in a timber under service loads. However, knots are treated as voids in the timber for purposes of assessing strength ratios and reference design values for flexure and axial compression. Per ASTM D245, and the grading rules of the WWPA, knots in simple span beams and stringers are permitted to be larger near the middle of the wide (vertical) face of a stick, that is centerline knots, but their permitted

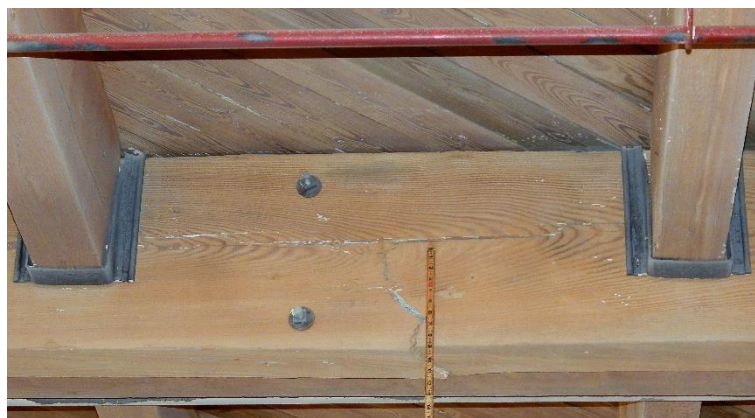
Figure 29 Fracture terminating at a check

Checks, Splits and Shakes: Checks, splits and shakes can typically be ignored when grading bending members in situ for strength if reference design values from the NDS or as derived by using the method of ASTM D245 are used. The design values for shear parallel to grain have already been reduced by a strength ratio of 0.5 to account for the worst case wherein a shake or split extends

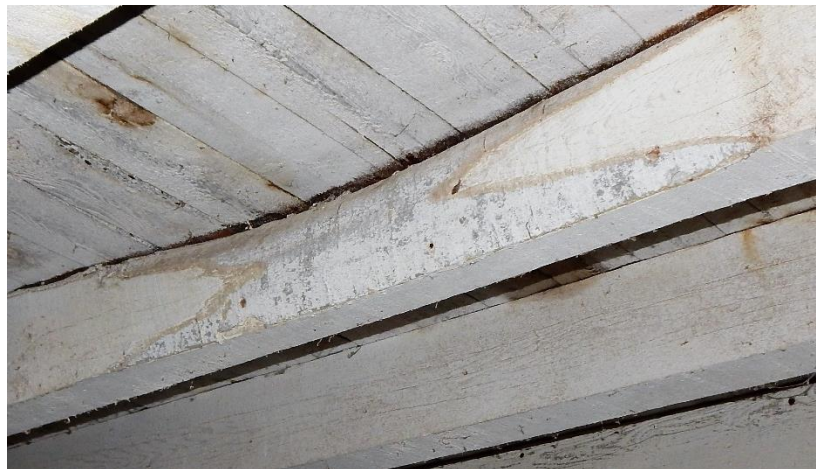
Figure 30 Excessive wane that exceeds grading rule limits

Clearly wane reduces the cross-sectional area of a timber where it occurs and would similarly seem to affect the other section properties. Recall that knots are considered as voids in the timber and result in strength ratios being applied to reduce the allowable stresses on the gross (not net remaining after the knot is discounted) cross section, yet no strength ratio or other reduction is indicated for wane. The question arises as to why this is, and when a given amount of wane too much.

If the investigator encounters wane in high bending stress regions of a timber, or in heavily loaded tension or compression members, that exceeds the limits for the grade as determined by other relevant strength-reducing features, the recommendation of this guide is that the piece be evaluated at the critical sections on the basis of adjusted design values for the grade as determined without respect to wane, with the cross-sectional area, section modulus and moment of inertia reduced to account for the area lost due to wane. Slope of grain in those regions with wane must remain within limits for the grade. This approach should result in conservative estimates of capacity and serviceability.

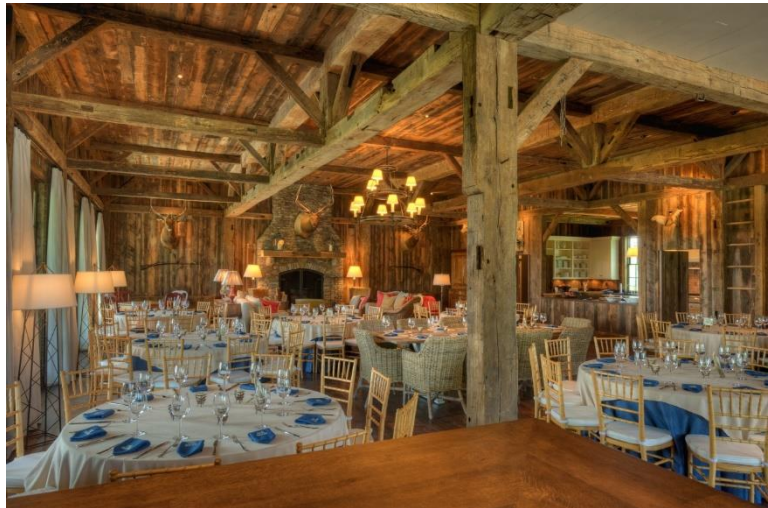
Figure 31 Reclaimed barn timbers with open mortises. Photo credit: Carolina Timberworks

The NDS incorporates restrictions on size and location of holes and notches in new construction to prevent or reasonably limit the effect of such alterations on member capacity. These rules appear to have been written specifically with dimension lumber framing in mind and do not adequately address the types of alterations that are common in timber construction. The *TFEC 1 Standard for Design of Timber Frame Structures* also restricts full width notching on the compression and tension faces of bending members. TFEC 1 permits partial width notches and holes, such as at housings and mortises, and provides methods for accounting for their effect on section properties.
